Maryland Historical Trust State Historic Sites Inventory Form

Survey No	• но-631
Magi No.	
DOEye	s <u>no</u>

1. Nam	e (indicate pr	eferred name)		
historic Willia	am Hollifield House		-	
and/or common				
2. Loca	ation			
street & number	8262 Old Frederic	k Road		not for publication
city, town E11	icott City	vicinity of	congressional district	
state MD		county	Howard

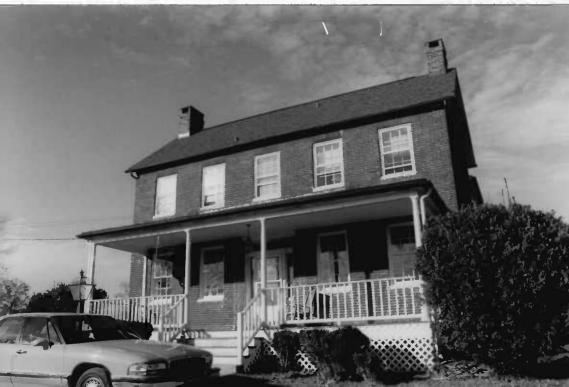
HO 631 1 of 6 Villian Hollifield House Howard County . MO David T. Robinson NOV 23, 1990 5251 Bamburg Ct Frederick, malzino3 South Elevation of Wm Hollifield House · DEC 96 233 NNNN A.

The South (main) elevation is pierced by four six over six windows on the first floor. The first floor entrance is flanked by four light side lights and a four light transom above the door. Five six over six double hung windows pierce the second floor. Jack arches top the windows and a large wood lintel crowns the front door. The cornice is defined by an offset row of bricks. A modern porch stretches across the South elevation. An earlier picture and ghosts on the brick reveals a smaller, gable - roofed porch with wood posts. The new porch stretches almost the entire length of the South elevation and has four columns supporting a hipped roof.

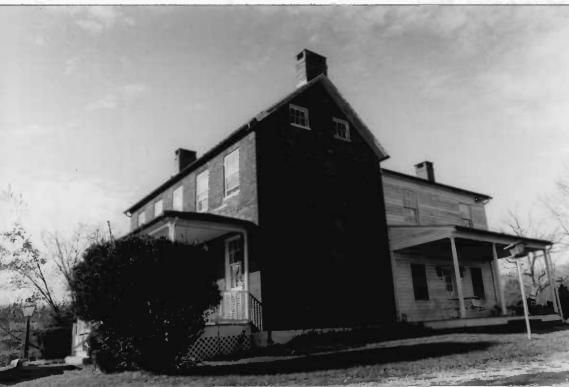
South and East Elevation of Win Hollifield House DEC 96 233 NNNN 3.---

The East elevation is pierced by two three over three gable windows flanking the interior set chimney. Jack arches top each window. There are no windows on the first or second floor. A modern addition can be seen on the North side of the East elevation. This modern addition on the rear of the home now fills in the entire area adjacent to the original rear el, converting the floor plan into a large square instead of an el.

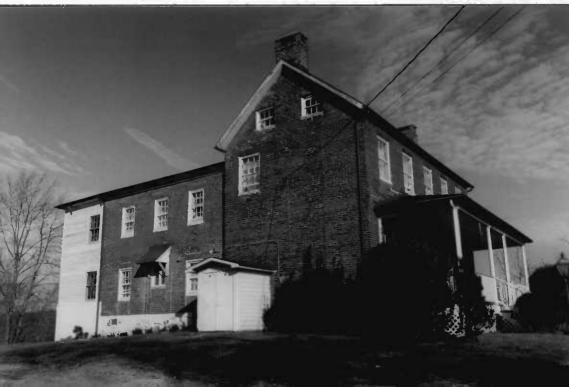
3 of 6 William Hollifield House Howard County MO David T Robinson Nov 23, 1996 5251 Gamburger Freduck MO 21703 West Elevation of Wm Hollford House

The West elevation of the main block and the rear addition is also mostly intact. There is a small framed shed attached to the house at grade level serving as an entrance to the cellar. The West elevation is pierced by two gable three over three windows flanking the interior set chimney. Jack arches top each window. A six over six window pierces this elevation on the left side of the second floor. There are no windows on the first floor of this elevation. A small vent pieces the foundation of the West elevation of the rear ell. Three six over six windows pierce the second floor of the West elevation of the rear el. The first floor now has a modern center window flanked by two six over six windows. The center window has a small wooden awning over it. A modern framed mudroom exists

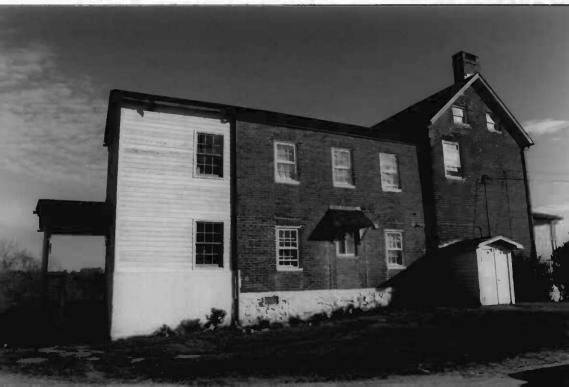
4 of 6 William Hullifield House Howard County mo David T Robinson Nov 23, 1996 Frederica, me 21703 West Elevation of William House

on the back of the el. A ghost reveals that a porch and door once existed where a window and wooden awning now exists.

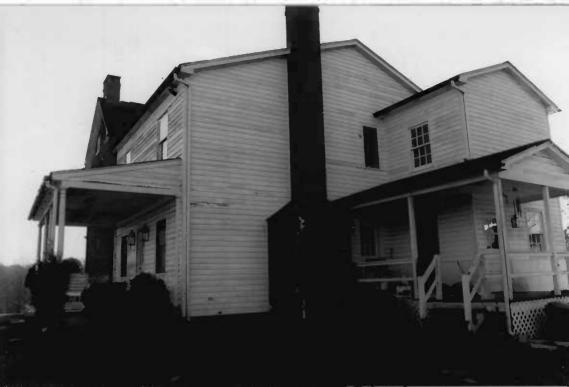
HO631 William Hollifiell House Howard County, mo David T Robinson Nov. 23, 1996 5251 Bumburg Ct Frederick, MO 2003 DEC 96 233 NNNH North Elevation of William Hollifield

The modern rear addition and the mudroom occupy the North elevation. The only elevation of the rear el now visible is the West elevation. As stated previously, the roof framing over the rear el no longer exists. One large, low sloped gable roof is now framed above the original el and the new rear addition

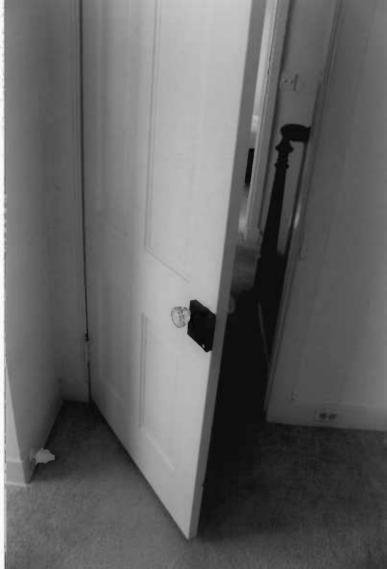
William Hollifield House Howard County mo David T. Robinson Nov. 23 1996 5251 Bamburg H Frederick, mo 21703 East 2nd Floor Room looking toward CEMEL STAIL 4 panel door

The first floor West parlor has modern built-in cupboards which hide the original fireplace. The first East parlor has a fireplace and mantle. The mantle has two simple pilasters and a mantle shelf. The second floor center bay is occupied by a modern bathroom. The room on the East contains a fireplace with a mantle with a keystone and much wider molding. The room West side of the center hall has a fireplace with a marble mantle also with a keystone which is possibly original. The original wood flooring is covered by carpeting on the second floor.
